Avoiding Issues with Hardwood Sapwood

Lyctus Susceptible Hardwood Sapwood

Non lyctus susceptible hardwood sapwood

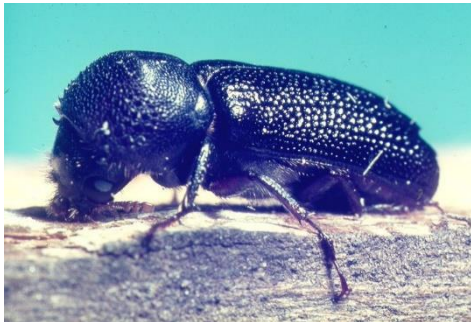
Figure 1. Lyctus beetle
to powder

Some hardwood sapwoods contain starch, e.g., spotted gum, tallowwood and alpine ash, which attracts the lyctus beetle. It lays its eggs in fallen trees and any sawn timber that has sapwood containing starch. The larvae hatch out and eat the sapwood which turns it to powder. Further, the timber keeps getting re infected until it the sapwood has totally disintegrated. There is no situation a specifier will encounter where the sapwood of lyctus susceptible sapwood should be purchased untreated[1] though it is less of a problem in the cooler climates.[2] Before the widespread adoption of vacuum pressure impregnation (VPI) timber containing any sapwood was regularly sawn into boards for flooring and treated to what we now call H1 with a borax solution.[3] The Timber Utilisation Acts in Queensland and New South Wales had very strong penalties for selling untreated lyctus susceptible timber. With their repeal, there are increased incidents of untreated lyctus susceptible timber being sold.

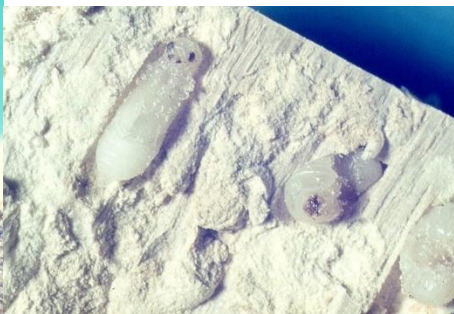
Figure 2. Lyctus larvae turning sapwood
to powder

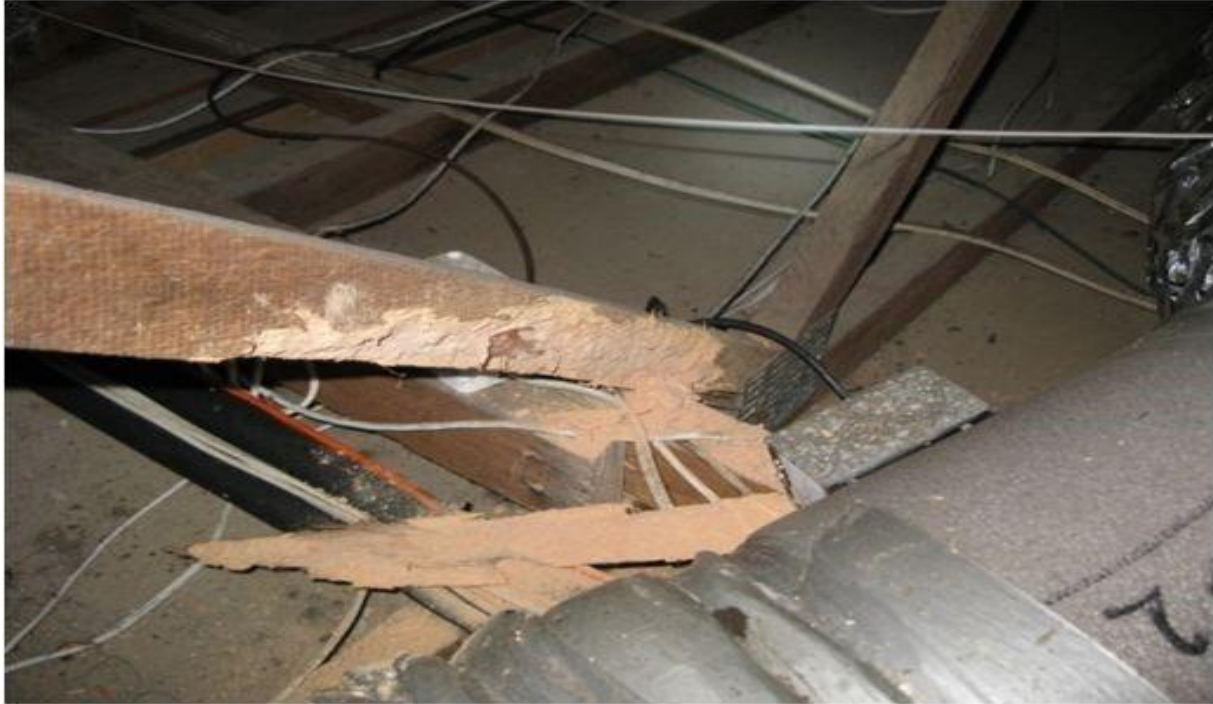
Figure 3. Lyctus attack on a truss member

The allowance for want and wane under AS2082 is very generous and even after the lyctus attack in the spotted gum roof truss web in Figure.3, it still likely meets the want and wane requirements of F17. However, what does the nail plate connect to, thin air? The web may as well not exist.

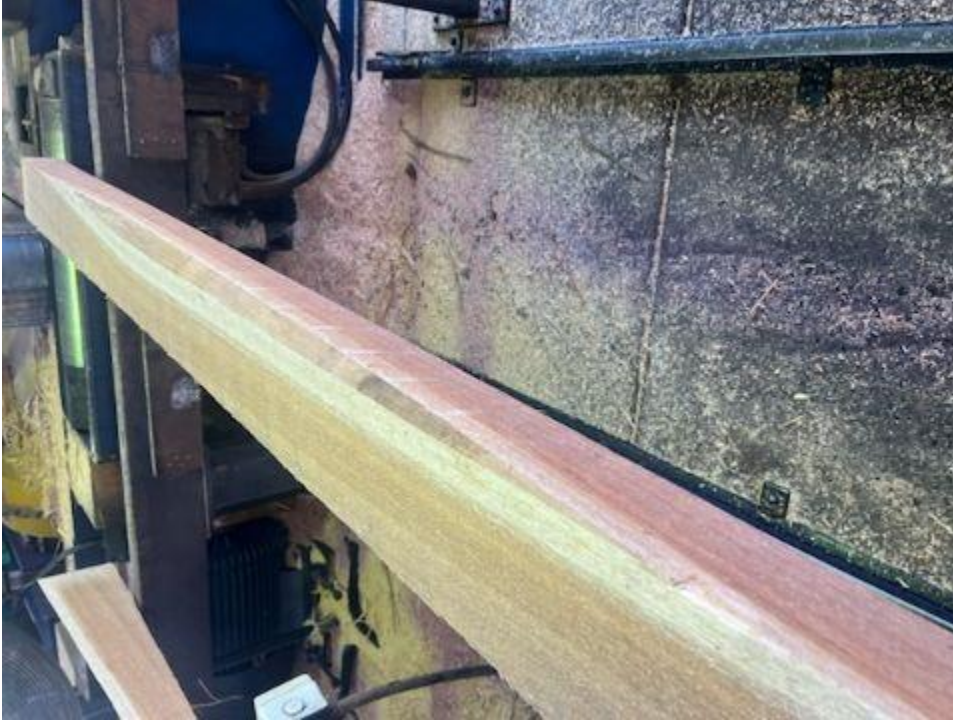
Figure 4. Freshly sawn blackbutt with sapwood clearly visible

Blackbutt is a species that is not susceptible to lyctus attack because its sapwood does not contain starch. I described blackbutt earlier in the book as "sub optimal" for external use but in an environment where we are spoilt for choice with higher performing species. For protected environments it is a highly prized species because it is strong, easier to work than the denser timbers and, very importantly, does not require any preservation as seasoned timber lacks the moisture needed to allow decay. Its light colour makes it ideal for decorative applications (Figure.4). But that all changes with external use.

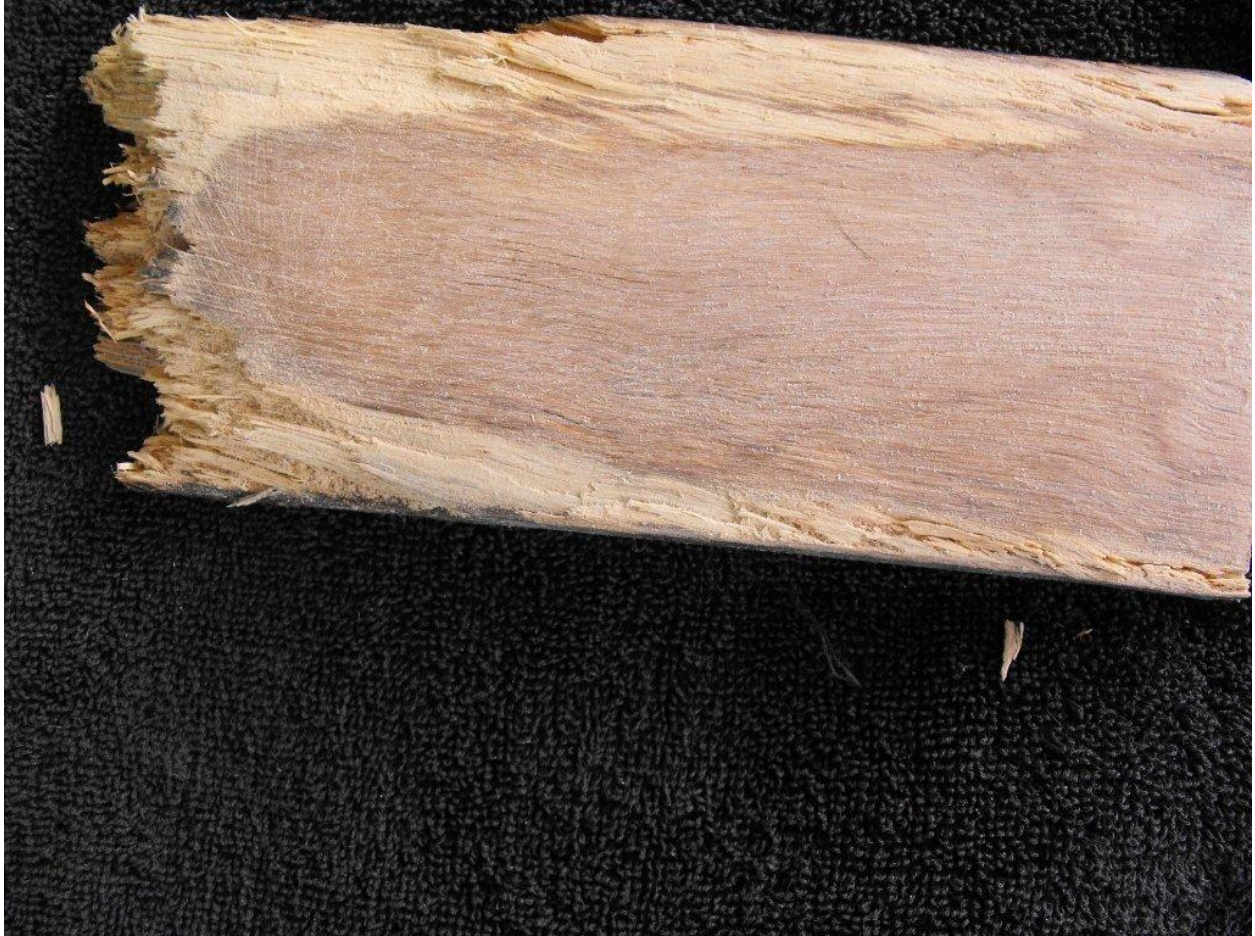
Figure 5. Decay in a blackbutt sapwood in a verandah joist

The extent of the non lyctus susceptible sapwood in Figure 5 is so great that it caused a deck to fail. Clearly, it isn't always so large that it effects structural integrity, but safety goes far beyond actual failure. The ironbark decking in Figure.7 has untreated sapwood on the top face, (it is identified by the light colour). Ironbark sapwood is rated as the same durability as pine sapwood, i.e., class 4 in ground and above ground, however in practice it is more durable than pine but only by a few years and not decades. The decay in Figure 8 is from the same boardwalk situated in Ipswich, Queensland after ten years. The decking is still capable of carrying the required load, but unacceptable trip hazards are now developing. It is critical that all external sapwood is treated to H3, whether it is lyctus susceptible or not.

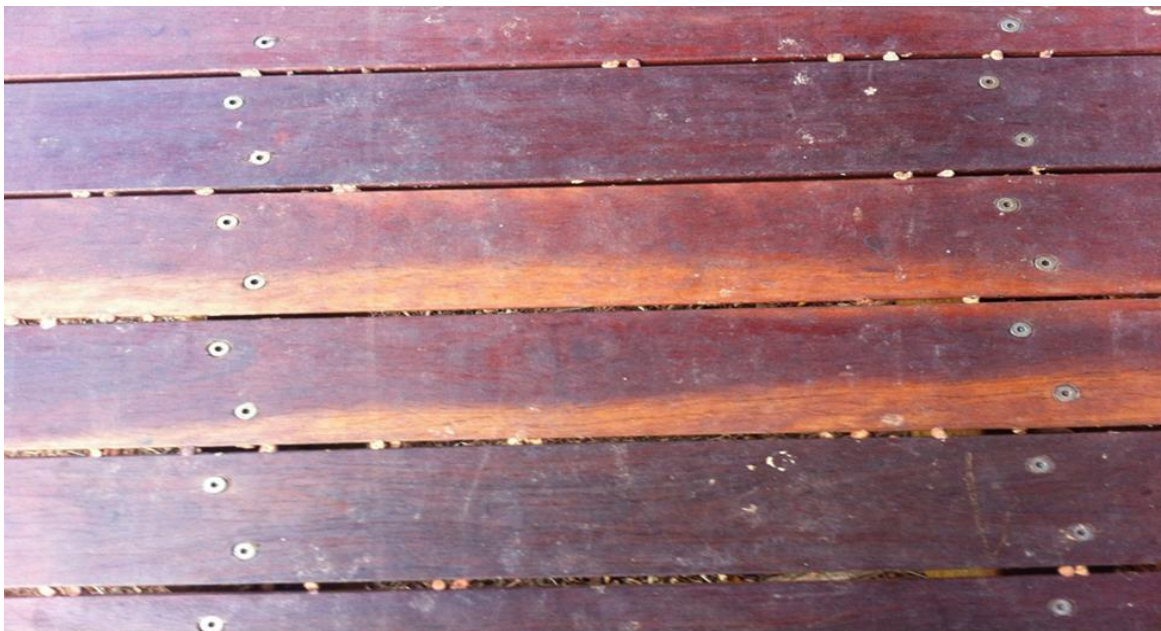
Figure 6. Ironbark decking with untreated sapwood

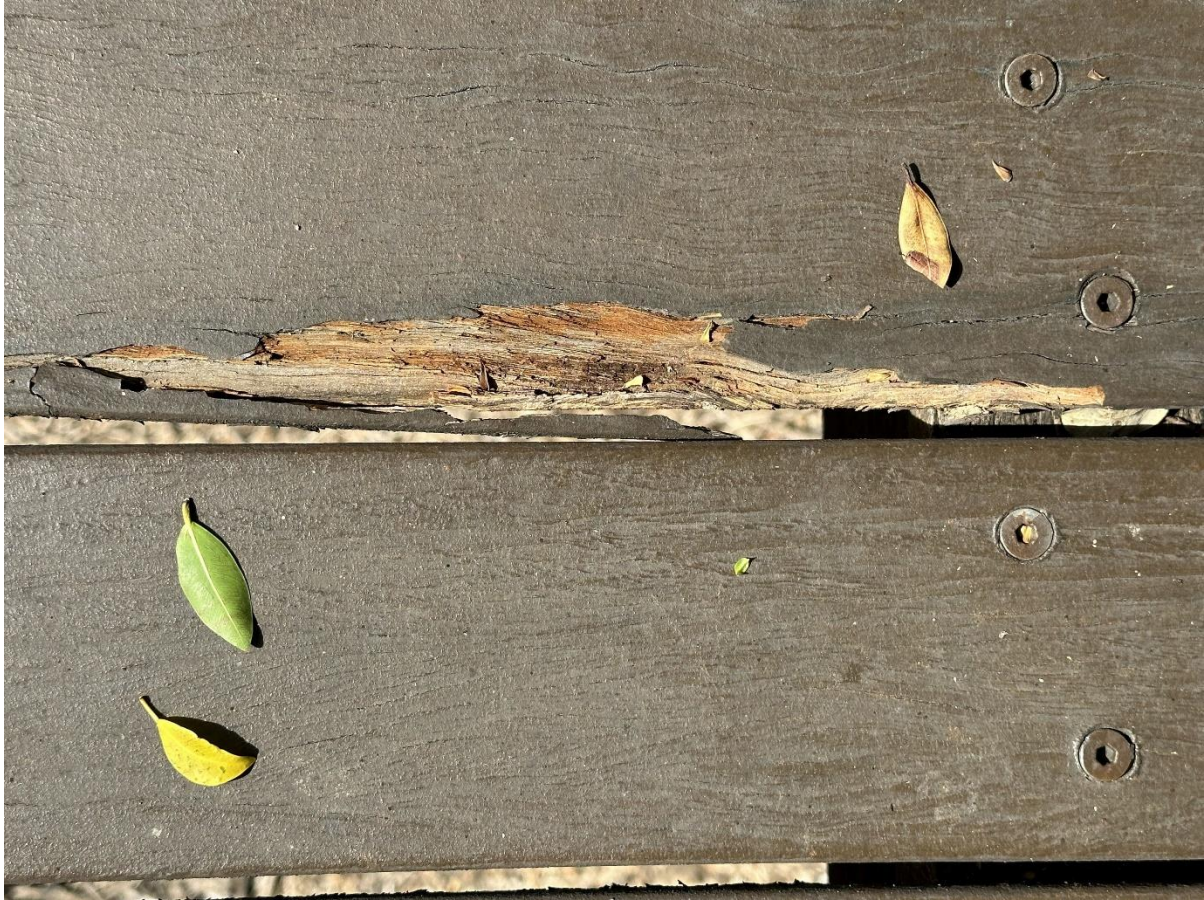
Figure 7. Untreated sapwood in sapwood is decaying
